CROSS SECTION MICROSCOPY ANALYSIS RESULTS

Light Tower Interior Paints
Burnt Coat Harbor Light Station

Swan's Island, Maine

March 7, 2014

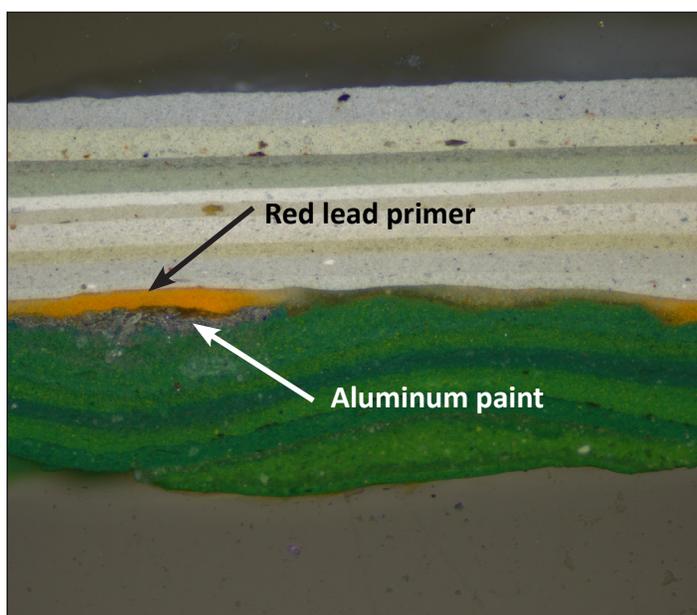
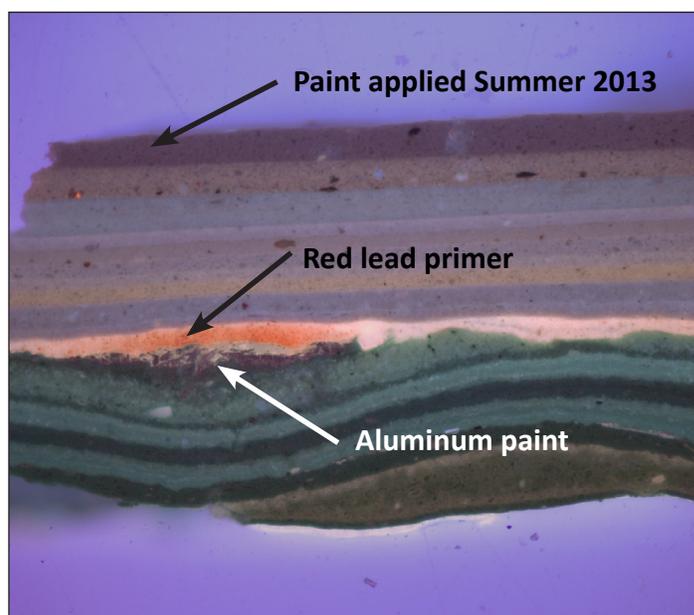
Fresnel Lens Pedestal: The combined stratigraphies of sample 1 taken from the base of the lens pedestal and sample 2 from the neck of the lens pedestal documents roughly 12-13 generations of green paint layers under roughly 7 generations of light to medium gray paint layers, ending with the gray paint applied during the summer of 2013. A red lead primer layer in a varnish separates the green paints from the gray paint layers. The pedestal base sample has more gray layers than the pedestal neck sample, and the pedestal neck sample has more green layers than the pedestal base sample. The earliest remaining paint on the pedestal neck sample (sample 2) appears as a partial layer of a granular dark gray paint in the cross section. This layer is readily visible in the uncast pieces of the sample as a thick, granular very dark gray / black layer. Sample 3 has the same gray generations (14-20) as sample 1 from the pedestal base.

Sample bc-1, Lantern: lens pedestal, base of pedestal, 100x vis

Sample bc-1, Lantern: lens pedestal, base of pedestal, 100x uv

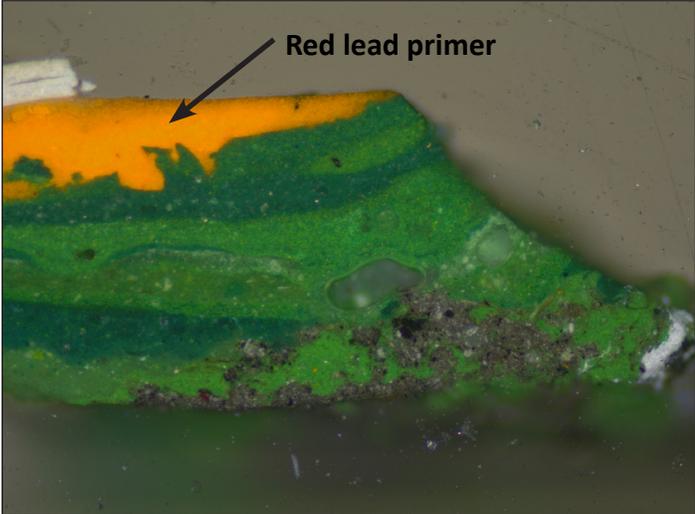
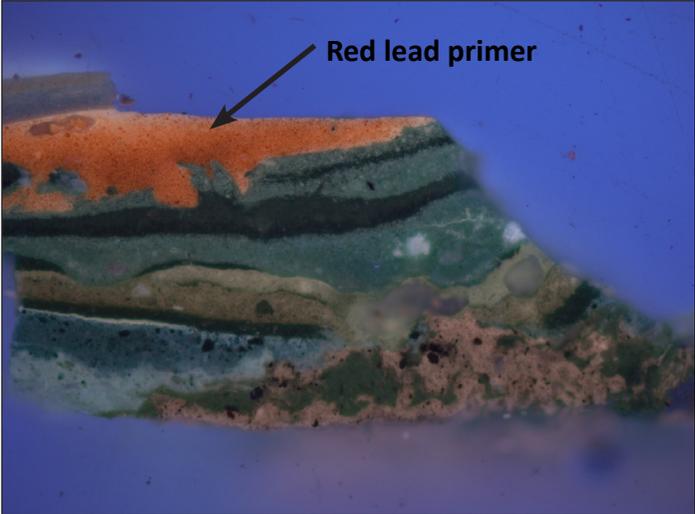
The thick red lead primer in sample 2 for the upper gray paint layers seeps down into the fragmented and broken top green layers which have the appearance of being disturbed by scraping or sanding. This disruption may indicate that paint layers are missing from the middle of the paint history due to a paint removal campaign prior to repainting. In sample 1, there is a partial layer of aluminum paint under the same orange colored red lead primer layer. Aluminum paint was widely used as a primer in the middle of the 20th century. The earliest reference for its use as a priming coat I have seen, however, is in the 1935 *Instructions for Painting United States Coast Guard Vessels, Boats, and Stations* intended for "all types of floating equipment." Section 4 – Use of Aluminum Paint explains it may "be used as a priming coat in lieu of red lead" and that aluminum paint "composed of aluminum powder in water-resisting spar varnish" should not be mistaken for the "ready-mixed bronzing paints" that had been used up until that time. As such it is likely the primer layer dates from the late 1930s or later (keeping in mind the Lighthouse Service was transferred over to the U.S. Coast Guard in 1939). While it cannot be unequivocally proven the green layers under this primer layer date from the 1930s (because the disturbed appearance of the top green layers seem to indicate paint layers were removed prior to the application of the primer coat) it may be a reasonable to say the pedestal could have been painted green at some point in the early 1930s because the dark autofluorescence of the middle and upper green layers in UV light indicate these are modern paints, which would have been available in the 1930s.

The dark gray paint at the bottom of sample 2 appears granular with medium and large black and white pigments visible in the gray matrix. The 1902 Instructions for mixing gray or lead color paint for outside work prescribe adding “lampblack (or black paint ground in oil) in small quantities to white paint, ground in oil, until the desired shade is obtained”.¹ It does not appear the directions for inside work were followed in this instance because the following recipe would have a different appearance in UV light. “Black paint for inside work may be prepared with dry lampblack, mixed with copal or coachmaker’s varnish and then thinned to the consistency of cream with spirits of turpentine”.² Interestingly, both the 1902 Instructions and the 1891 amendment to the 1880 Instructions prescribe the use of green for pedestals, with black being prescribed for “iron staircases and railings, and for interior ironwork in general, except pedestals and service tables.”

Sample bc-2, Lantern: lens pedestal, top of pedestal neck, 100x vis

Sample bc-2, Lantern: lens pedestal, top of pedestal neck, 100x uv

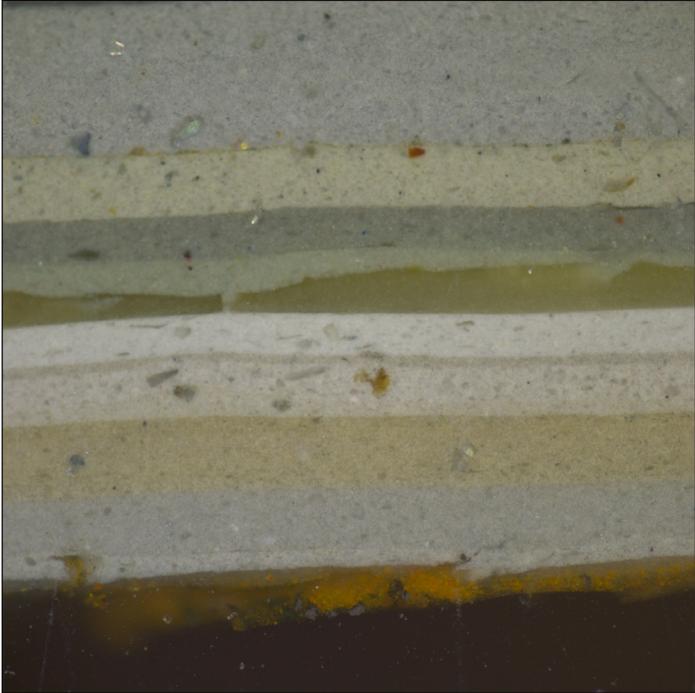
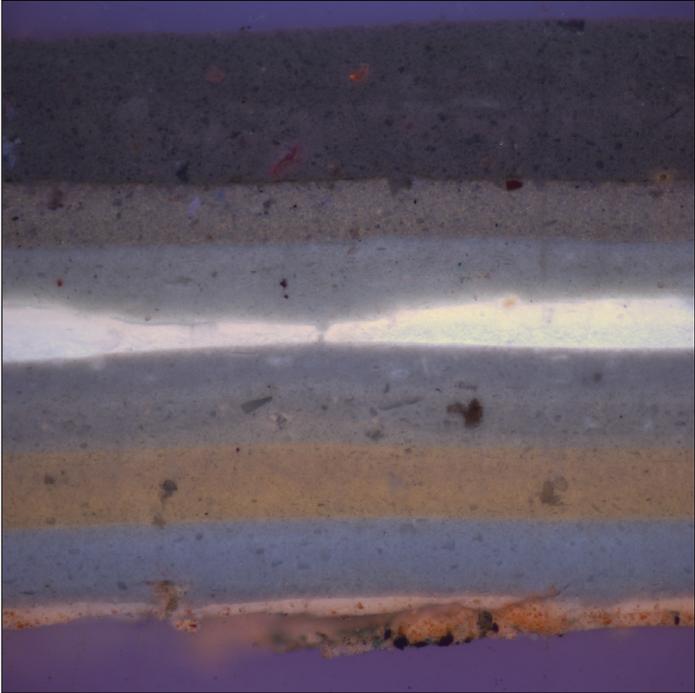
Sample bc-3, Lantern: lens pedestal shelf, 200x vis

Sample bc-3, Lantern: lens pedestal shelf, 200x uv

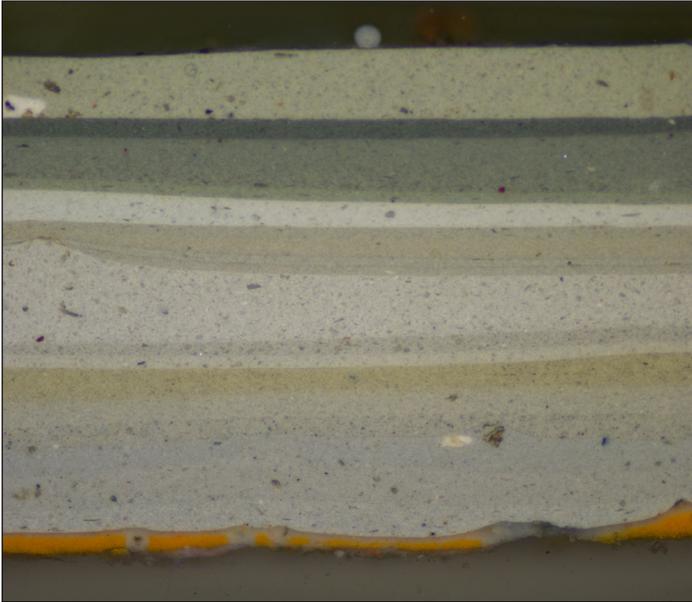
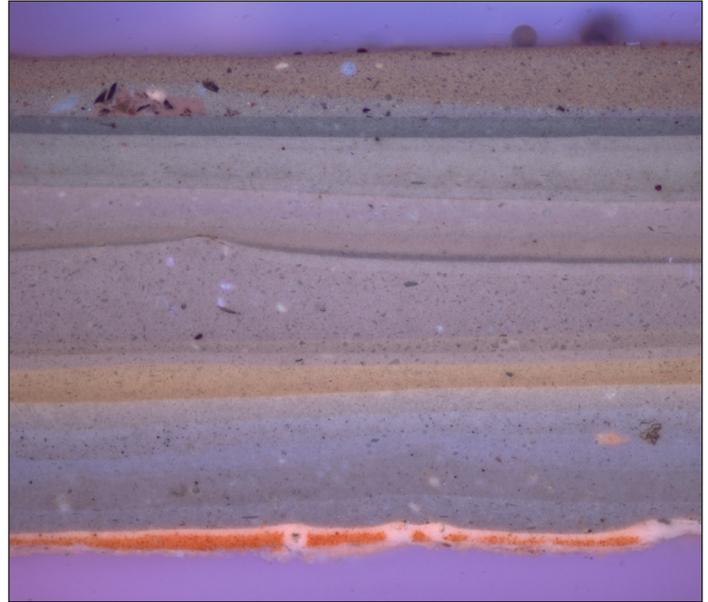
Lantern Floor: The paint layers for sample 6 from the metal lantern floor start with the same (orange colored) red lead primer visible at the beginning of the gray paint layers on the Fresnel lens pedestal. The metal floor sample has seven more gray layers than the pedestal samples. These layers are interspersed with the middle of the gray layers on the pedestal and likely represent more frequent repainting of the floor, which would have experienced greater abrasion from traffic and weathering due to it being a horizontal surface vs. a vertical one.

Sample bc-6, Lantern: floor, 100x vis

Sample bc-6, Lantern: floor, 100x uv

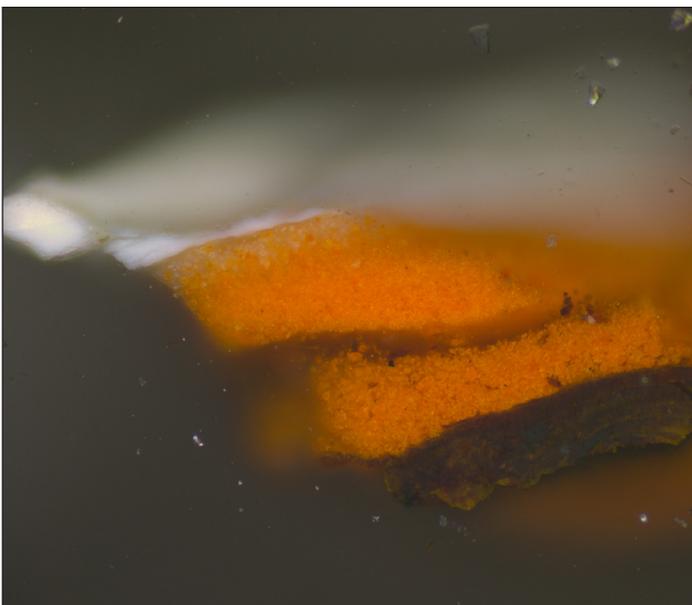
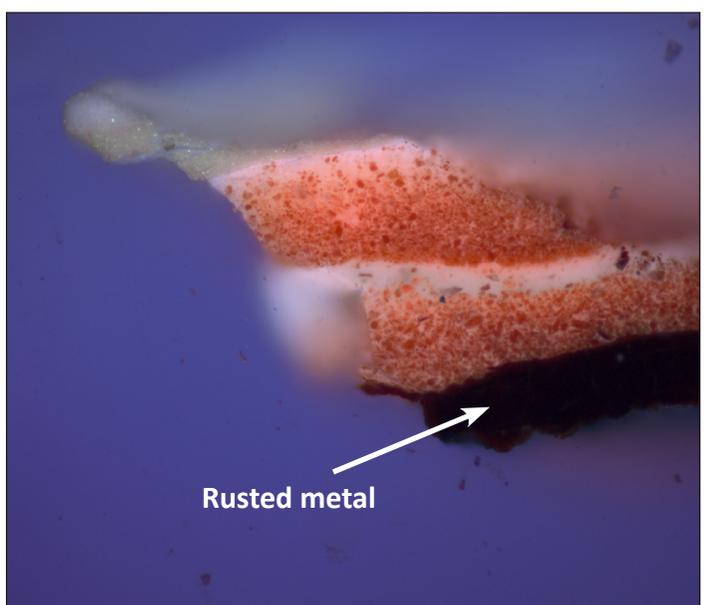
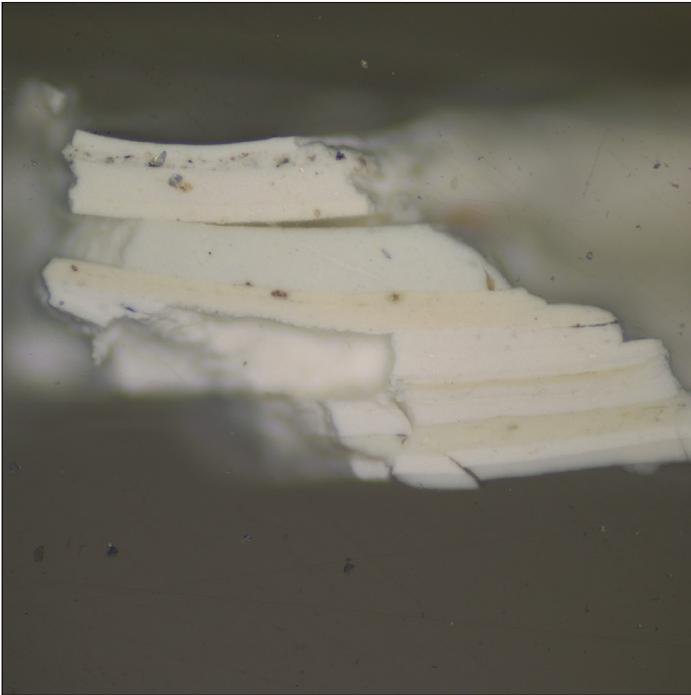
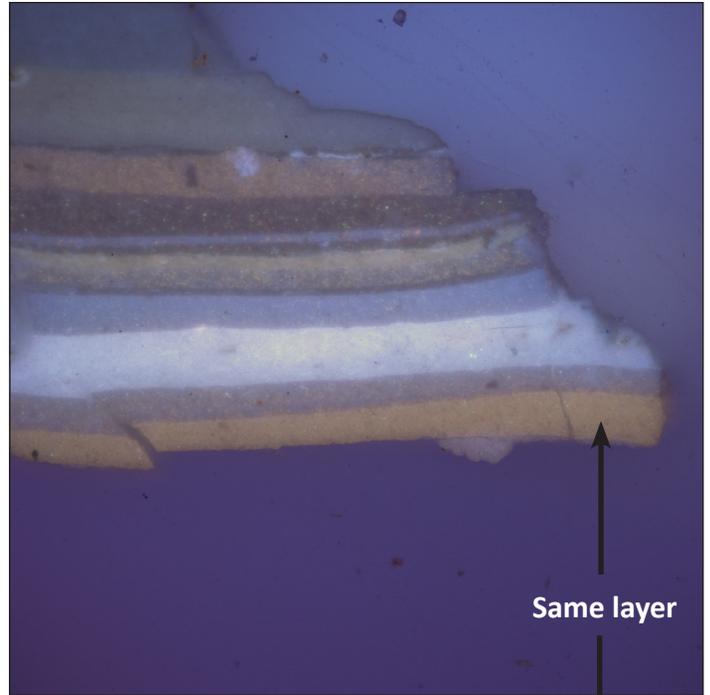
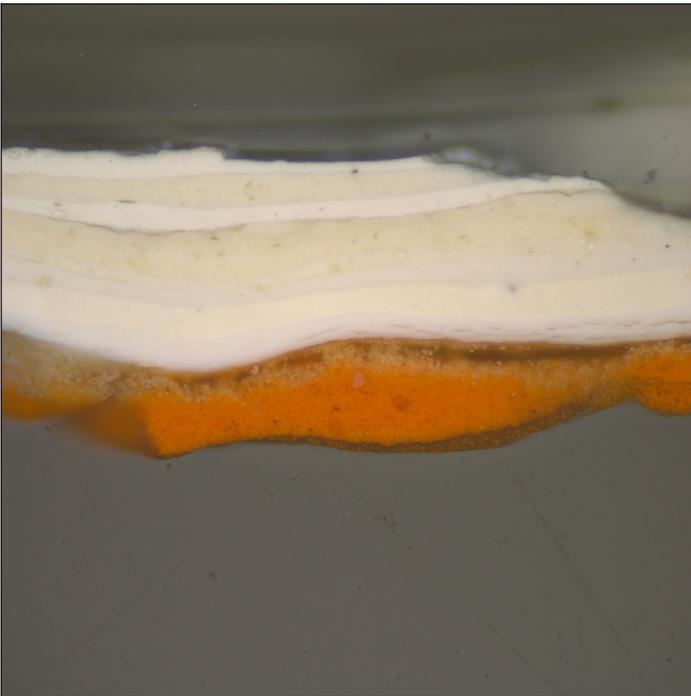
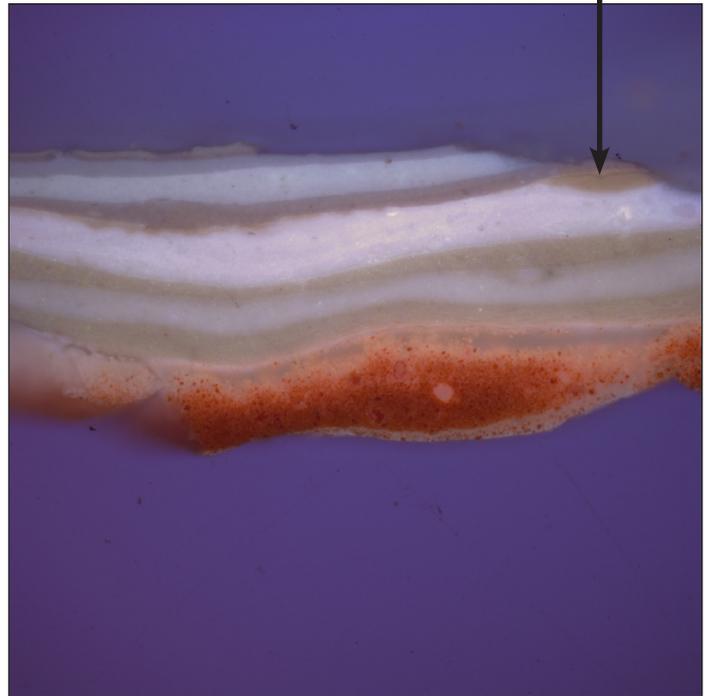
Lantern Windows and Ceiling: The lantern window frame with mullions (sample 5) and ceiling (sample 4) has paint stratigraphies comprised entirely of white paints which follow the prescribed painting instructions from 1871 – 1952. Sample 4 from the ceiling also starts with the same thick orange red lead primer as the floor sample. It is interesting to note there are two distinct layers of primer over deteriorated metal substrate. This evidence seems to reinforce the theory that a major repainting campaign of the entire tower took place in the early to post-WWII at a time when the paint layers may have substantially deteriorated.

Sample bc-4.1, Lantern: ceiling, 200x vis

Sample bc-4.1, Lantern: ceiling, 200x uv

Sample bc-4.3, Lantern: ceiling, 100x vis

Sample bc-4.3, Lantern: ceiling, 200x uv

Sample bc-4.2, Lantern: ceiling, 100x vis

Sample bc-4.2, Lantern: ceiling, 100x uv

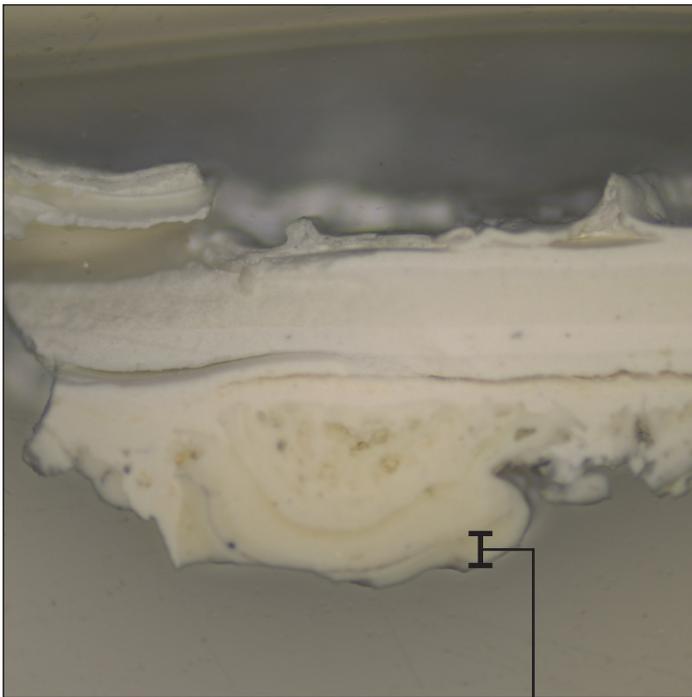
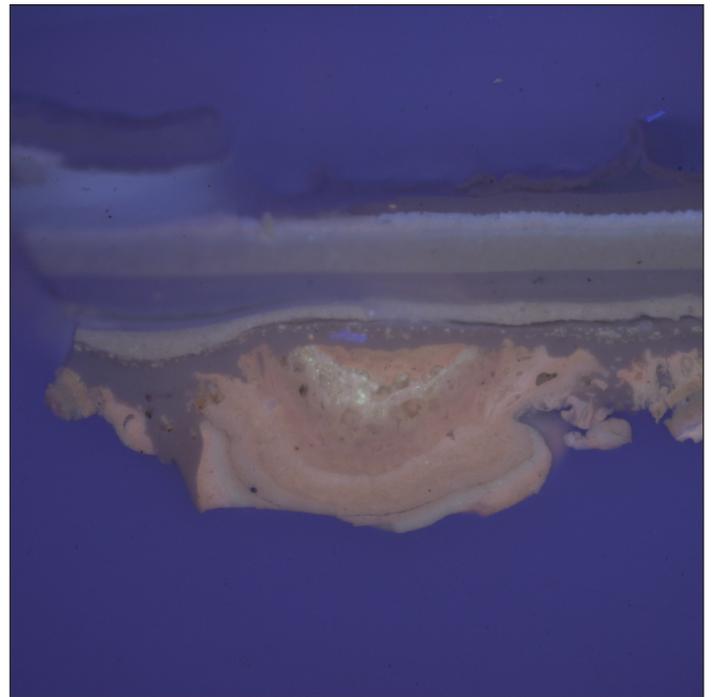
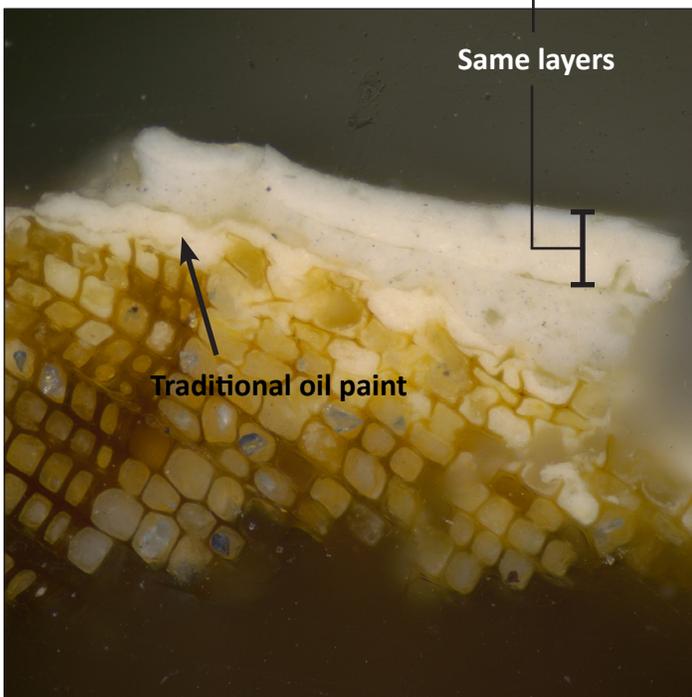
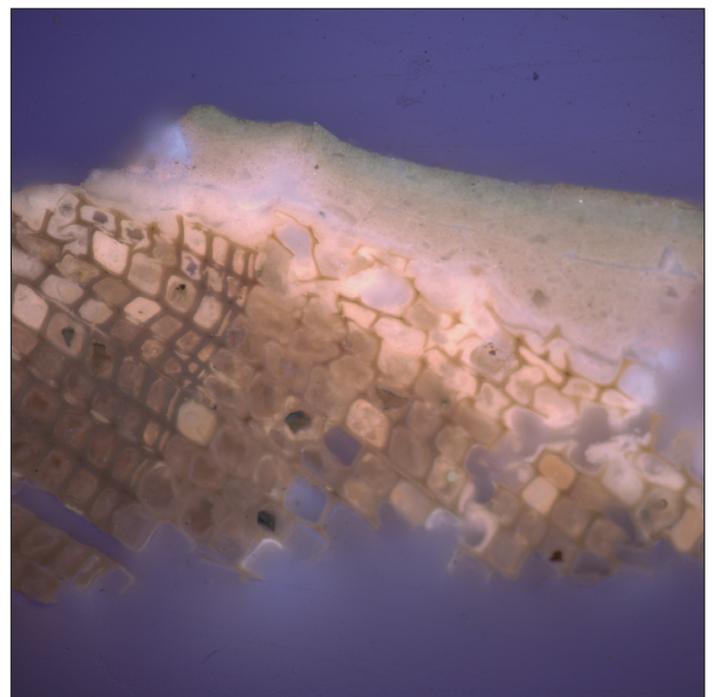
Wood Wainscoting: The sample 7 paint layering on the vertical beaded board parapet wainscoting is comprised of all white layers and includes what appears to be a traditional linseed oil and lead white layer as the earliest generation remaining visible in the fibers of the wood.

Sample bc-7.3, Lantern: wainscot, 40x vis

Sample bc-7.3, Lantern: wainscot, 40x uv

Sample bc-7.1, Lantern: wainscot, 200x vis

Sample bc-7.1, Lantern: wainscot, 200x uv

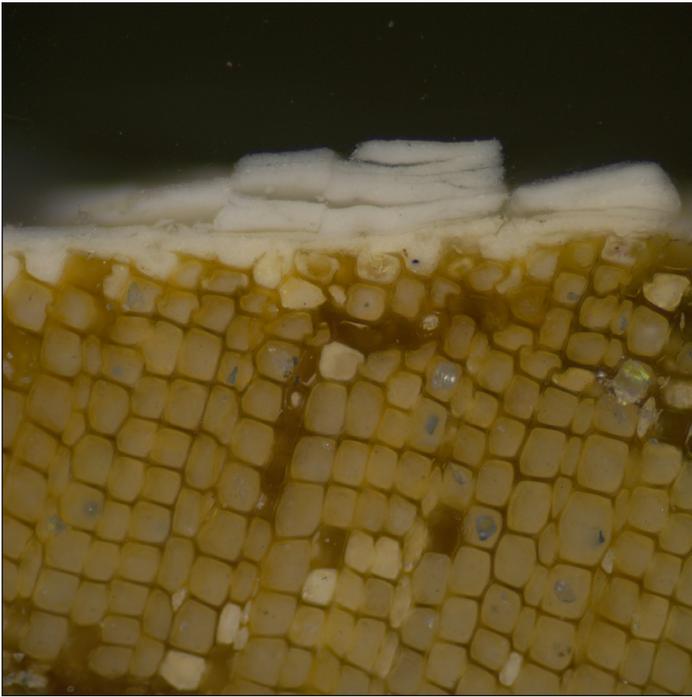
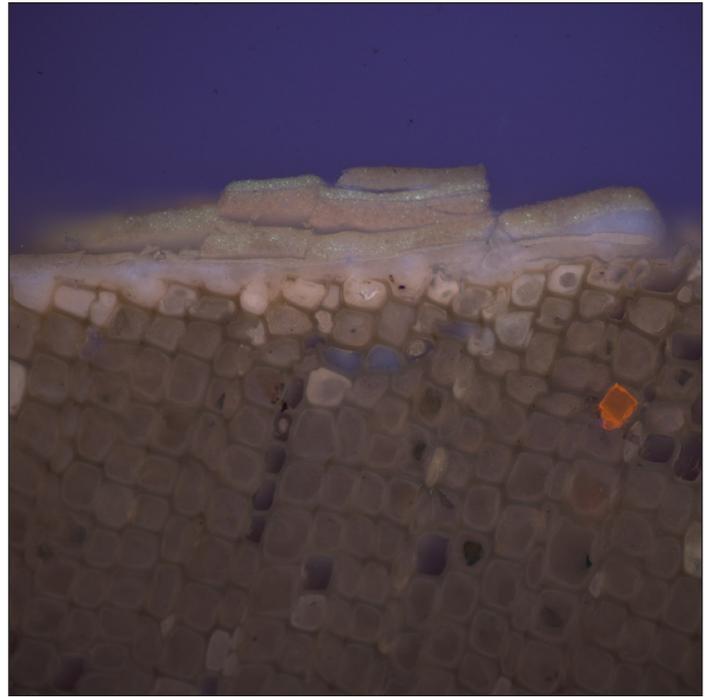
Door Frame and Partition: The door frame and the partition wall for the watch room (samples 11 and 12) contain only white paint layers. The earliest layer on the door frame appears to be a traditional linseed oil and white lead layer that is both in the pores of the wood and on top of the wood.

Sample bc-11c.1, Watch Room: door frame, 200x vis

Sample bc-11c.1, Watch Room: door frame, 200x uv

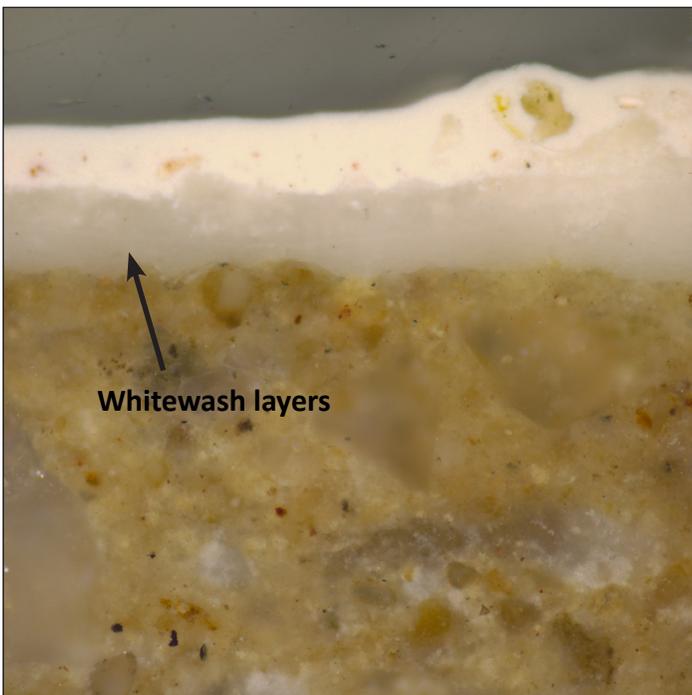
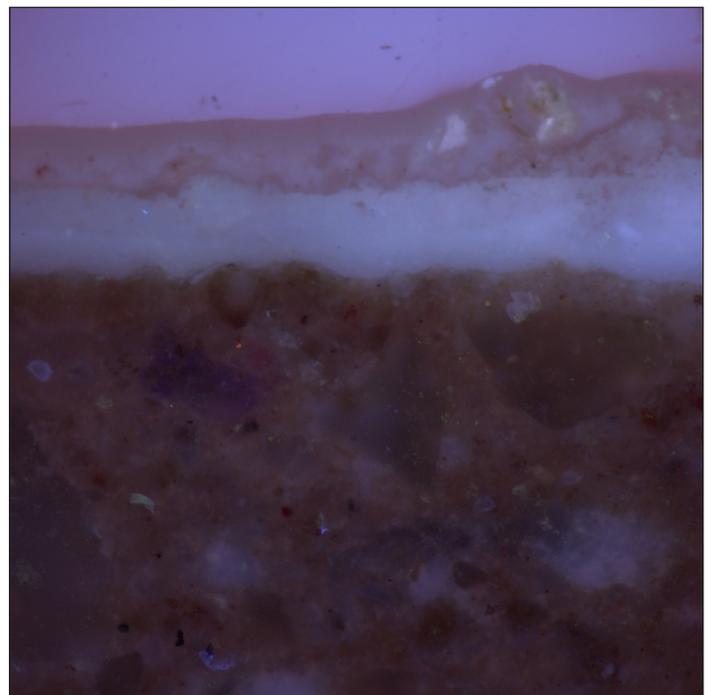
Brick Wall: The brick walls of the tower have been sand blasted to removal all paint layers. However, thin strips of paint do remain on the brick behind surface mounted conduits for light bulbs. The sample from the brick wall in the watch room (sample 13) was taken behind the conduit and appears to retain a couple layers of whitewash below a layer of oil based paint.

Sample bc-13, Watch Room: brick wall at light, 200x vis

Sample bc-13, Watch Room: brick wall at light, 200x uv

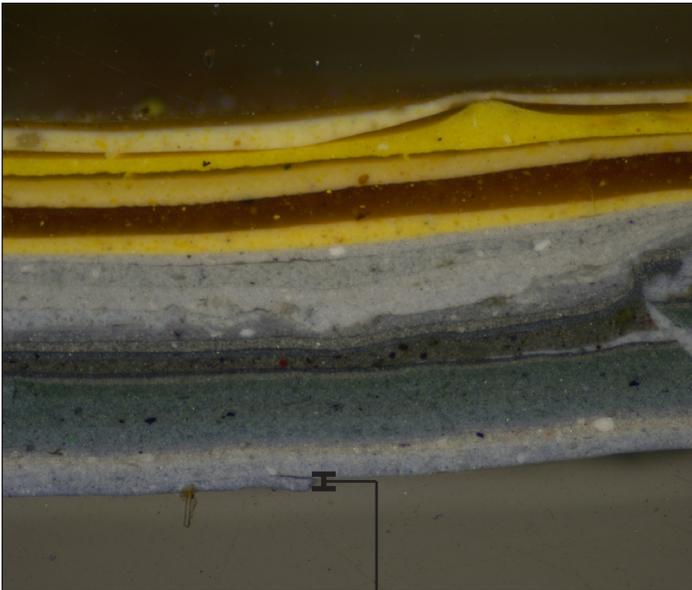
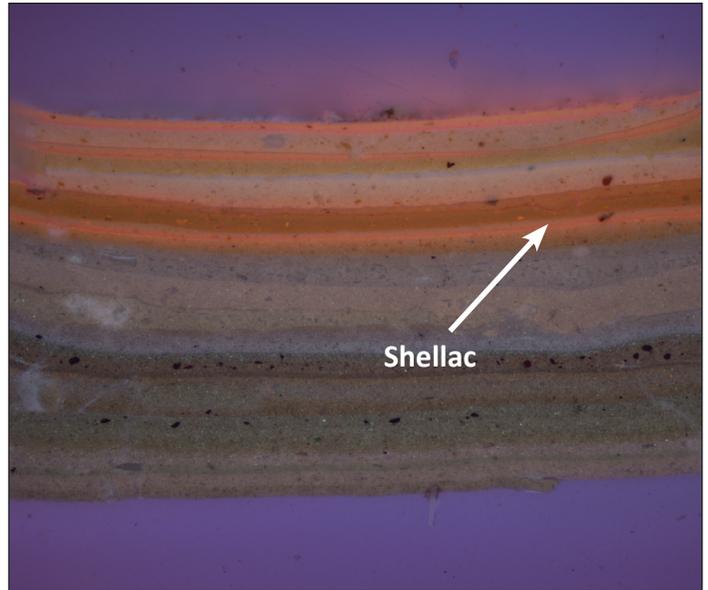
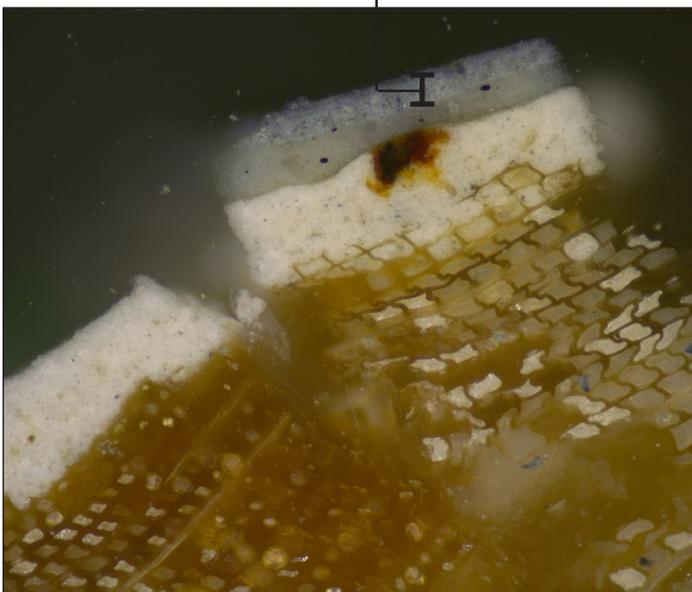
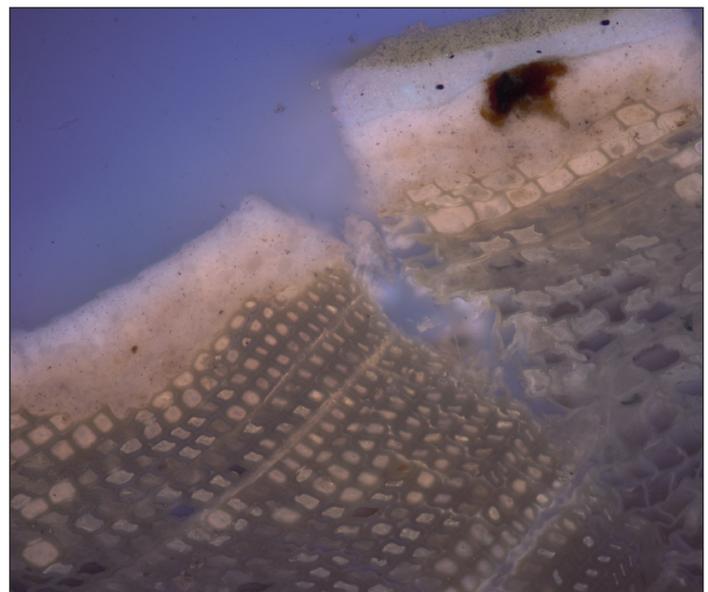
Sample bc-9.2, Watch Room: lower layer of flooring, 100x vis
Same layer

Sample bc-9.2, Watch Room: lower layer of flooring, 100x uv

Sample bc-9.1, Watch Room: lower layer of flooring, 200x vis

Sample bc-9.1, Watch Room: lower layer of flooring, 200x uv

Sample 9 from the lower floor boards first has a series of light blue-grays followed by medium grays and then light grays totaling 10 generations of paint (generations of paint are comprised of primer + top coat). The gray layers on the lower floor boards and are followed by 6 generations of yellow colored paint topped with shellac. If the lower floor was covered early in the 20th century, the thick accumulation of paint on the lower floor boards would indicate the floor was repainted about every 1-2 years, which is believable given how much this softwood floor would have been worn over the course of a year by the keepers constant attention to the lamp in the Fresnel lens in the lantern above. A keeper's log entry from July 18, 1874 – just shy of two years after the Burnt Coat was placed in service says “Painted the upper room floor in the rear tower.”

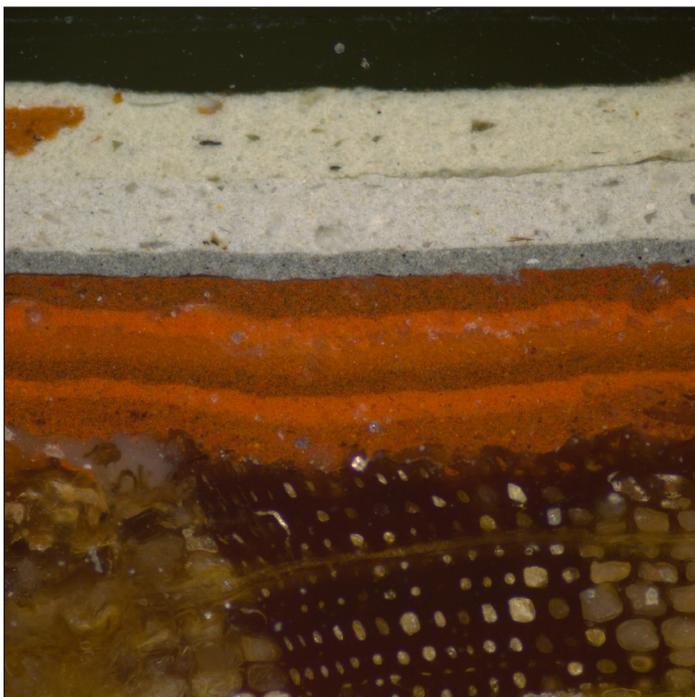
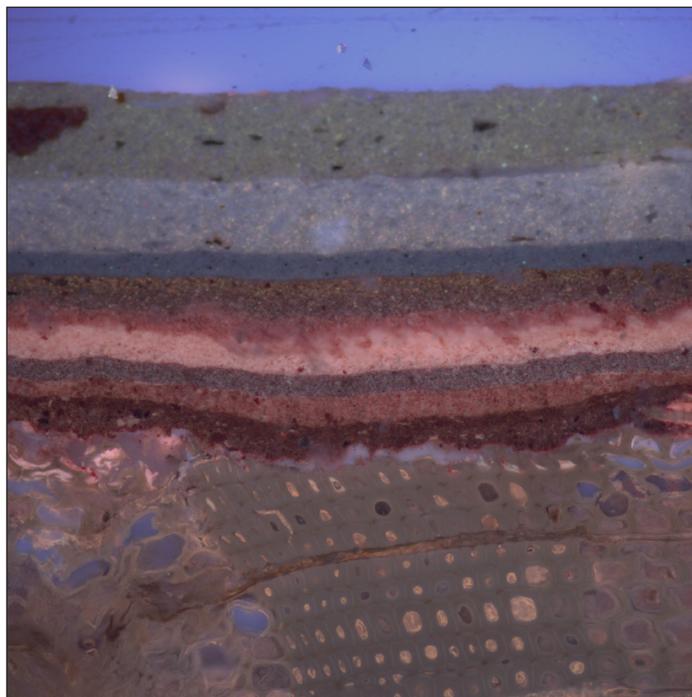
Sample bc-8, Watch Room: upper layer of flooring, 200x vis

Sample bc-8, Watch Room: upper layer of flooring, 200x uv

Sample 8 from the upper floor boards has noticeably fewer extant layers of paint than sample 9 from the lower floorboards. This sample only has four generations of reddish-brown paint and two generations of light gray paint. However, the wood is weathered and the fibers are compressed in this sample indicating the wood was unpainted, abraded by foot traffic or aggressively prepped prior to repainting. Page 53 of the 1902 Instructions to Light Keepers dictates “hard-pine floors and hard woods generally are not to be painted, but shall be kept well oiled and scrubbed.” If the upper floor was installed when the keeper's house was renovated at the turn the 20th century and the new floor was not painted for some time, it would account for the lack of earlier red-brown paints that are present in the threshold sample 10. The dark red-brown paints that are present in sample 8 are more finely ground paints like the later red-brown paints in sample 10. The early and middle red paints on threshold sample 10 include shellac and varnish layers over the red paints that are not surviving on floor sample 8 with the exception of a partial shellac layer on the wood and below the first red paint.

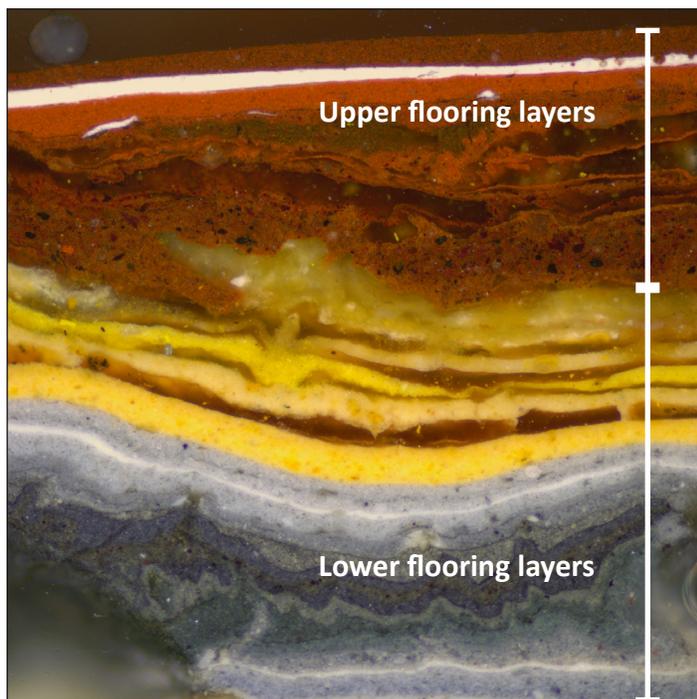
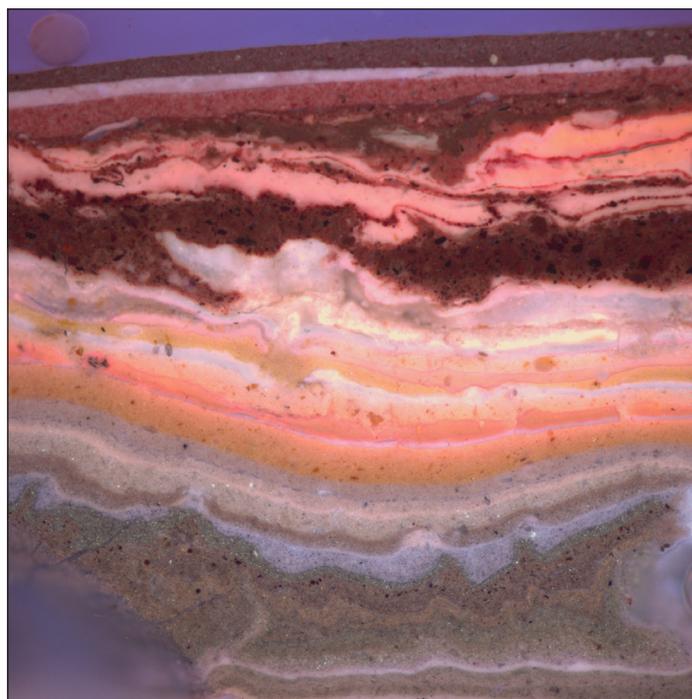
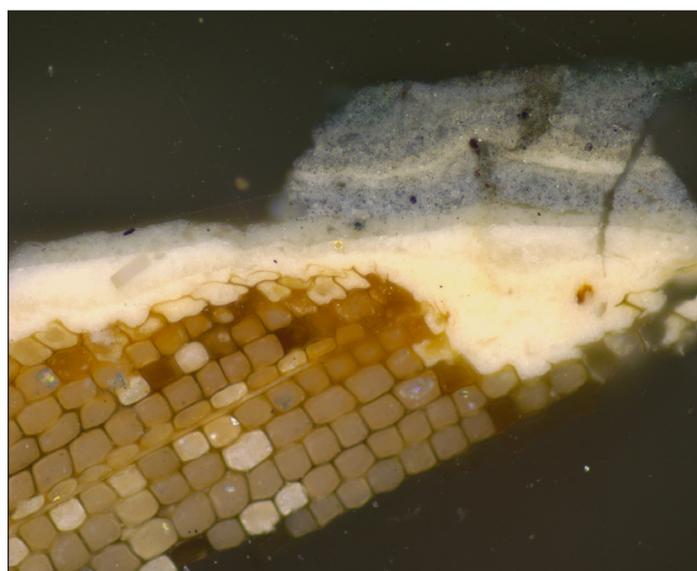
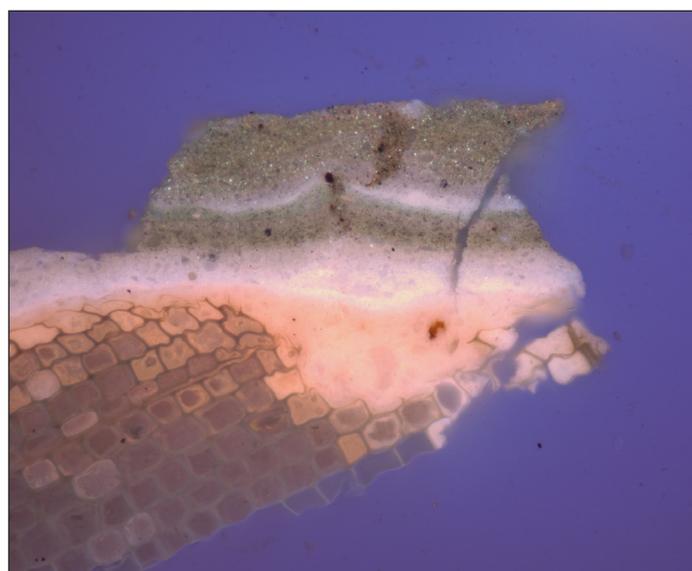
Sample 10 from the Watch Room door threshold is notable because it contains 26 generations of paint without the late 20th century gray paints, which the sample is missing. It is also notable the threshold was painted the same color as the lower floor boards until the iron stair paint color changed to dark brown, at which time the threshold was changed to the iron stair color. This is apparent because the first layer of dark reddish brown paint in sample 10 matches the first layer of dark reddish brown paint in sample 15 from the iron stairs. This may, in fact, be the strongest evidence to date the installation of the top flooring, to coincide with the shift of the iron stair color from black to dark brown.

Sample bc-10.2b, Watch Room: door threshold, 100x vis

Sample bc-10.2b, Watch Room: door threshold, 100x uv

Sample bc-10.1, Watch Room: door threshold, 200x vis

Sample bc-10.1, Watch Room: door threshold, 200x uv

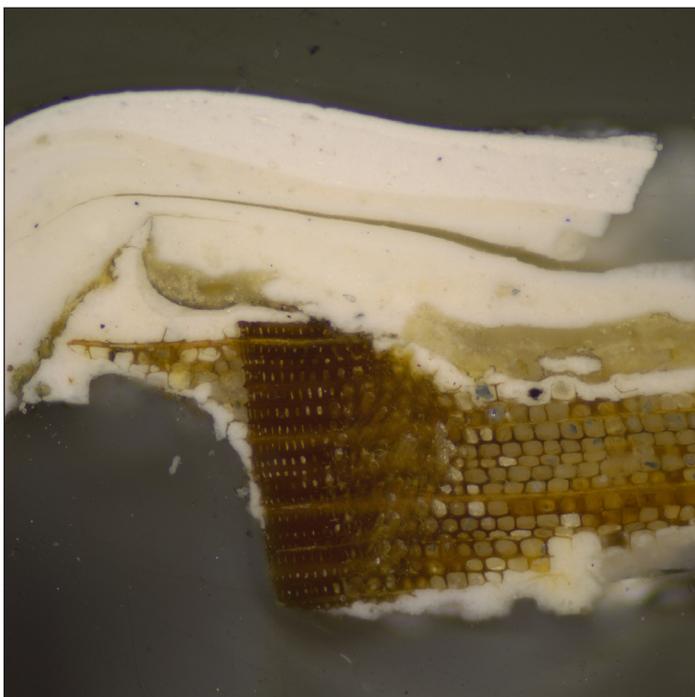
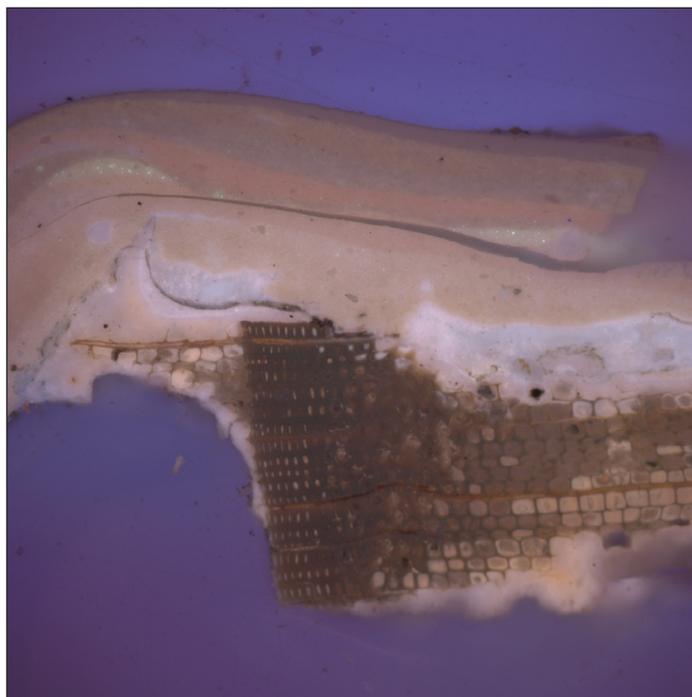
Underside of Watch Room Floor: The watch room floor is wood joist construction set into the inner wythe of the exterior brick walls. On the west side of the tower a small brick barrel vault spans from the inner brick core of the tower to the exterior brick wall above the top run of stairs on the north side of the tower. On the east side of the brick vault is a rounded infill constructed with wood boards and a beaded board ceiling above the tower stairs adjacent to the watch room floor. This element appears to date from the original construction of the tower based on its materials and installation and because it is fastened to the wall with square headed nails. The paint layering on the wood elements above the stairway under the watch room floor (sample 14) is comprised of all white and off-white layers and includes what appears to be a traditional linseed oil and lead white layer as the earliest generation remaining visible in the fibers of the wood. Interestingly, the early oil paint also has a limewash above it in the layers, which is the finish historically used on the brick walls of the tower.

Sample bc-14a, Tower: underside of watch room floor, 100x vis

Sample bc-14a, Tower: underside of watch room floor, 100x uv

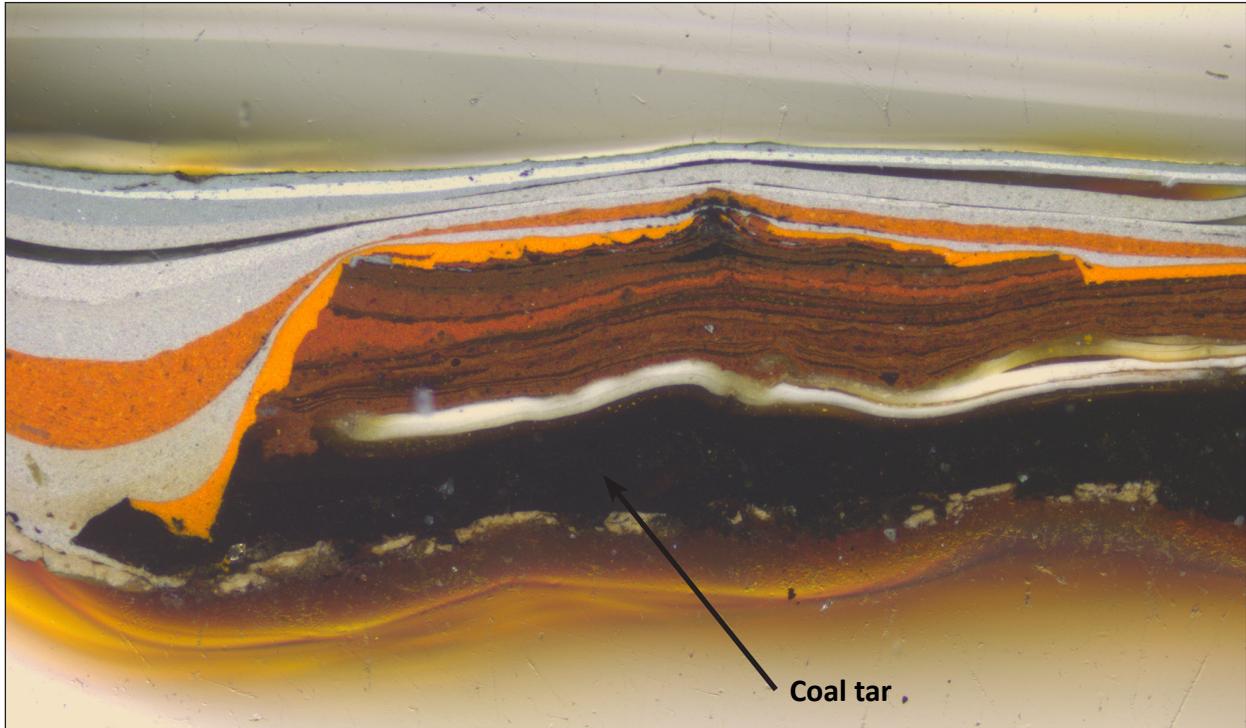
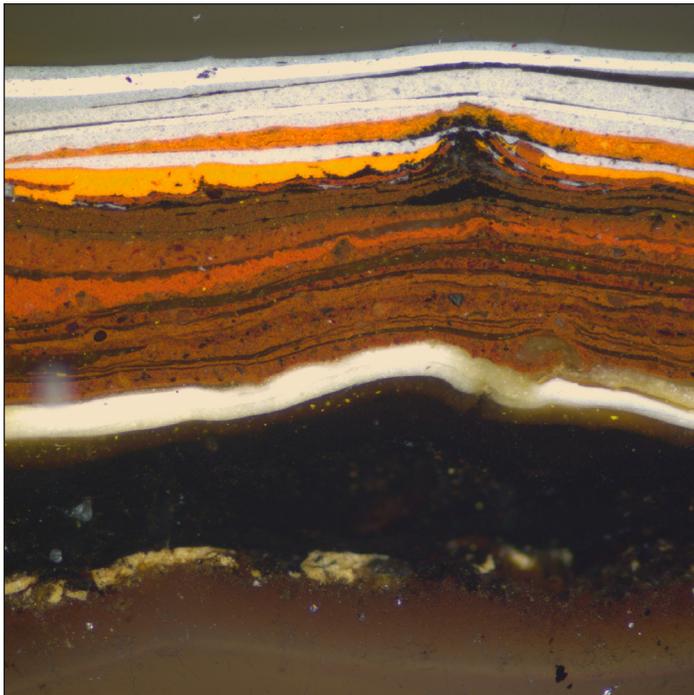
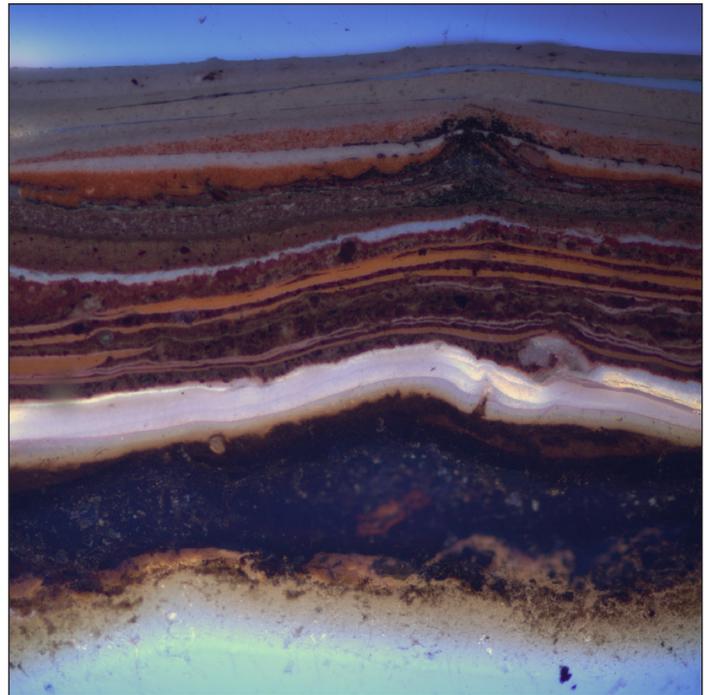
Iron Stairs in the Tower: Samples taken from the iron stair treads (samples 15a, b, c) are generally quite disrupted, exhibiting rust infiltration in the layers (especially 15a) and partial layers due to losses from abrasion and / or weathering. Sample 15b encompasses what appears to be a nearly complete stratigraphy for the stairs. The layering sequence starts with a thick layer of black coal tar seeping down around fragments of an oil based layer. There may also be a layer of black oil based paint above the coal tar. The coal tar layer is supported by documentation at the National Archives and in the published Light-House Establishment Instructions. In Light Station Keeper Allen's 1874 log book there are entries for: October 22, 1874 "Commenced to tar the rear tower steps but found it too cold" and November 2, 1874 "Finished coal taring the rear tower steps." Page 197 of the 1871 Regulations, Instructions, Circulars, and General Orders of the Light-House Establishment of the United States ordered the use of coal tar as follows: "Refined coal-tar will be issued for use on all iron-work which is not necessarily to be of another color, and no black paint is to be used where coal-tar will answer in color as a substitute." However, 1891 Amendment to the Light-House Regulations specified that "The use of coal tar and asphaltum varnish in painting light-house structures is prohibited, also lanterns and lantern decks."

Sample bc-15b 40x vis

Sample bc-15b, Tower: stair, 100x vis

Sample bc-15b, Tower: stair, 100x uv

The black layers are followed by roughly 6-8 generations of varnish layers, which are then followed by a considerable accumulation of dark reddish brown paints (roughly 18 generations) with a shellac or varnish top coat. These dark reddish brown paints with shellac or varnish top coats match the dark reddish brown paints on the threshold to the service room (sample 10). The shift to brown paint for iron stairs is ordered in the 1927 Instructions to Light Keepers. The earliest reference to the use of shellac in the Light Keeper's Log Books is July

The bright orange red lead primer marking the start of the gray paint layers noticeably spreads over the dark brown layers where were standing proud of the adjacent surface of the step which would have been scraped or abraded down to near bare metal. The weathered appearance of the top brown layer and the presence of mold spores on top of that layer appear to be evidence that more time and weathering elapsed between the application of the last brown paint and the new red lead primer than between the repainting of the earlier dark brown layers. The sequence of gray paints at the top of the sample follows the gray paints sequence of the lantern floor and pedestal paints.

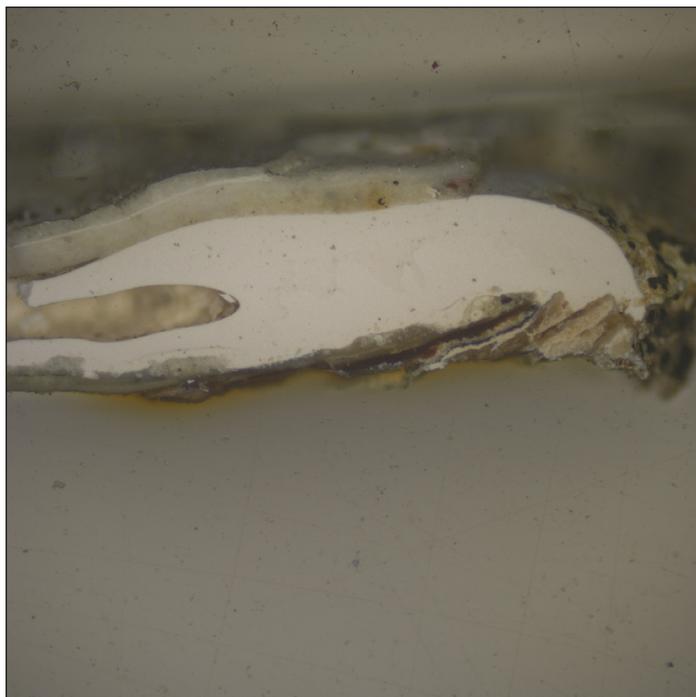
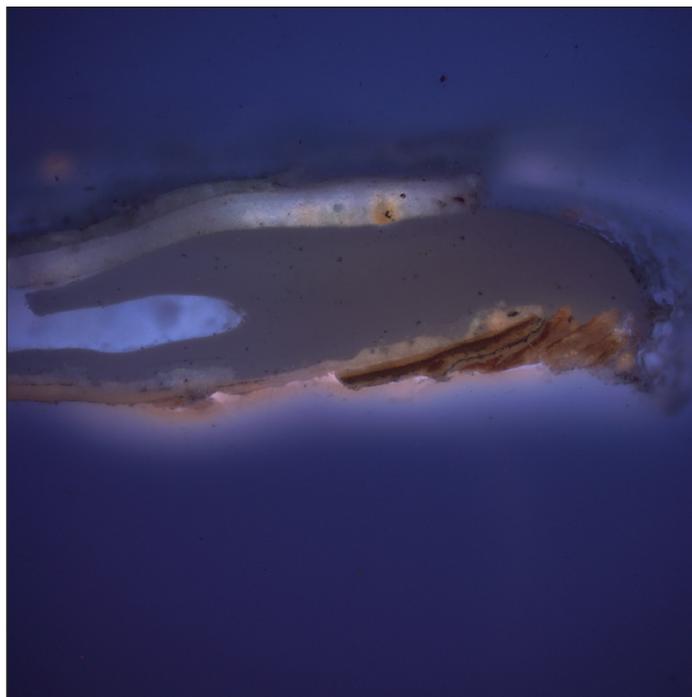
Sample bc-16a, Tower: wall, 40x vis

Sample bc-16a, Tower: wall, 40x uv

Wall: Samples taken from the brick wall (samples 16a, b, c) have lime wash on the bottom of the sample with modern white paint on top. Sample 16a, taken next to the stair sample 15a, appears to have stair paint over lapping the (rust infused) whitewash wall layer. There is a very thin black layer under a brown layer which correlates with the late 19th century color specification for stairs followed by the 1927 color specification for stairs.
