CROSS SECTION MICROSCOPY ANALYSIS RESULTS

Light Tower Interior Paints
Burnt Coat Harbor Light Station

Swan's Island, Maine

March 7, 2014

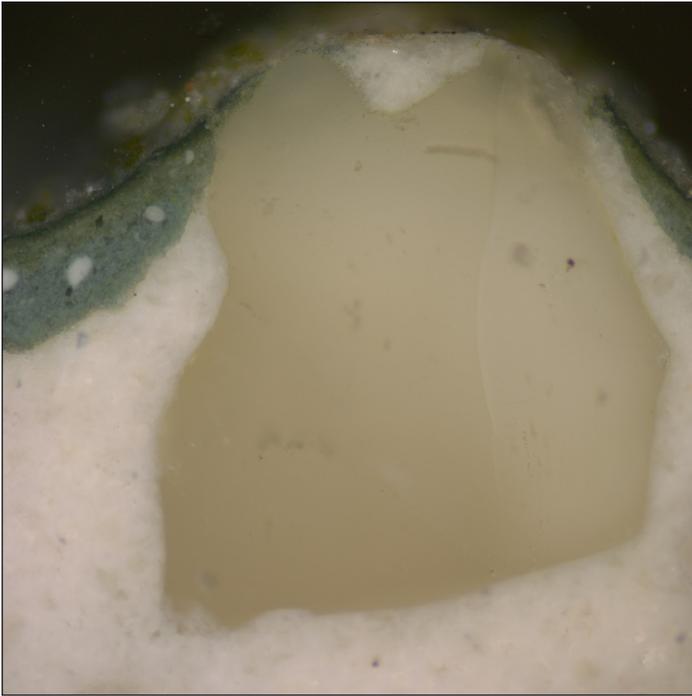
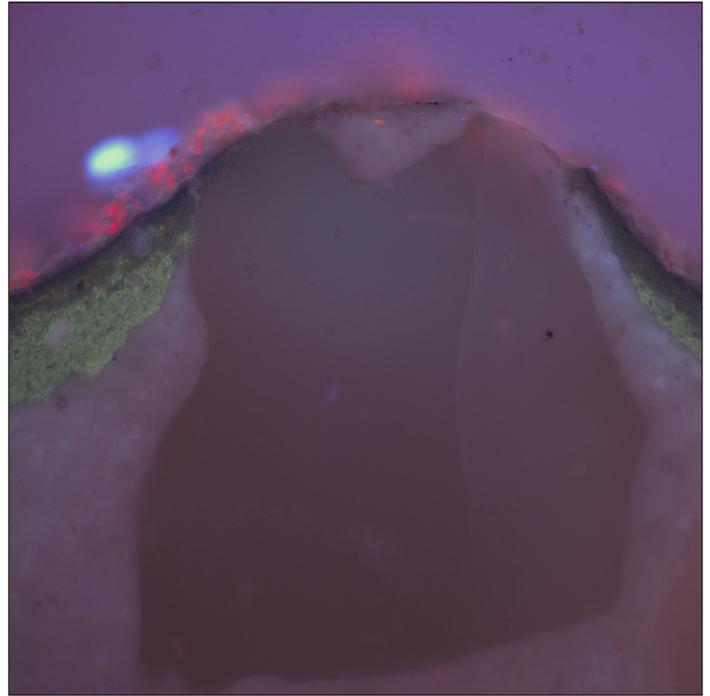
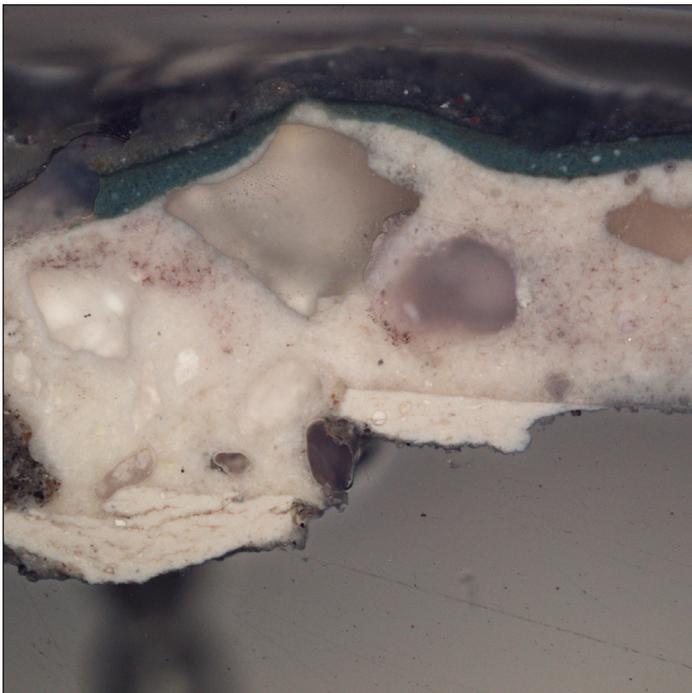
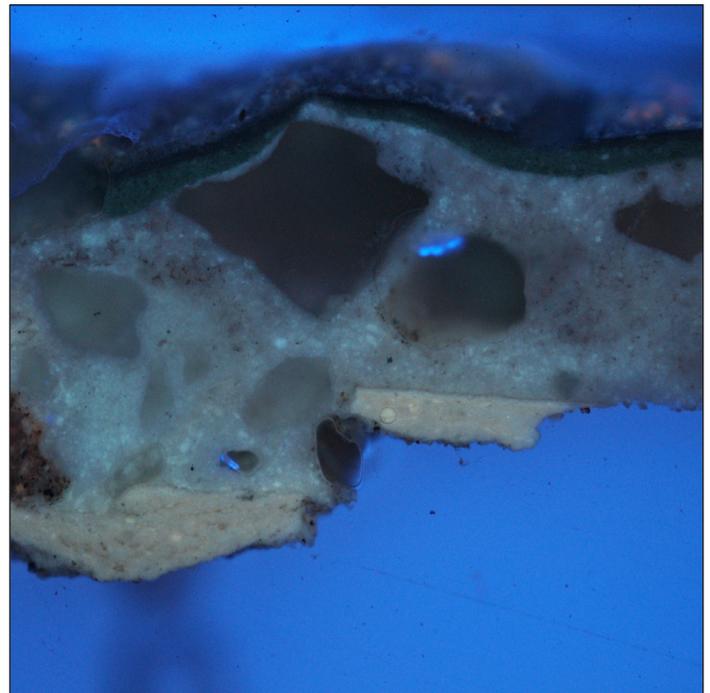
Window Frame: Sample 18 was taken from the masonry window opening. It is presumed that the wooden windows were removed and replaced with the current glass block c.1975 when the aid to navigation was automated. The sample was removed from where I estimated the wooden window would have been located in the masonry opening and based on a faintly visible paint ridge. The sample does have multiple layers of white paint as would be expected, but it also has some green paint layers (some of the green in the cross-section is actually bio-growth). The 1952 *Coast Guard Paint Manual* specified white for interior surfaces of windows and No. 12 Spruce Green for exterior window frames and sash.

Sample bc-18.1, Tower: window frame, 200x vis

Sample bc-18.1, Tower: window frame, 200x uv

Sample bc-18.1, Tower: window frame, 40x vis

Sample bc-18.1, Tower: window frame, 40x uv
