CROSS SECTION MICROSCOPY ANALYSIS RESULTS

Light Tower Interior Paints
Burnt Coat Harbor Light Station

Swan's Island, Maine

March 7, 2014

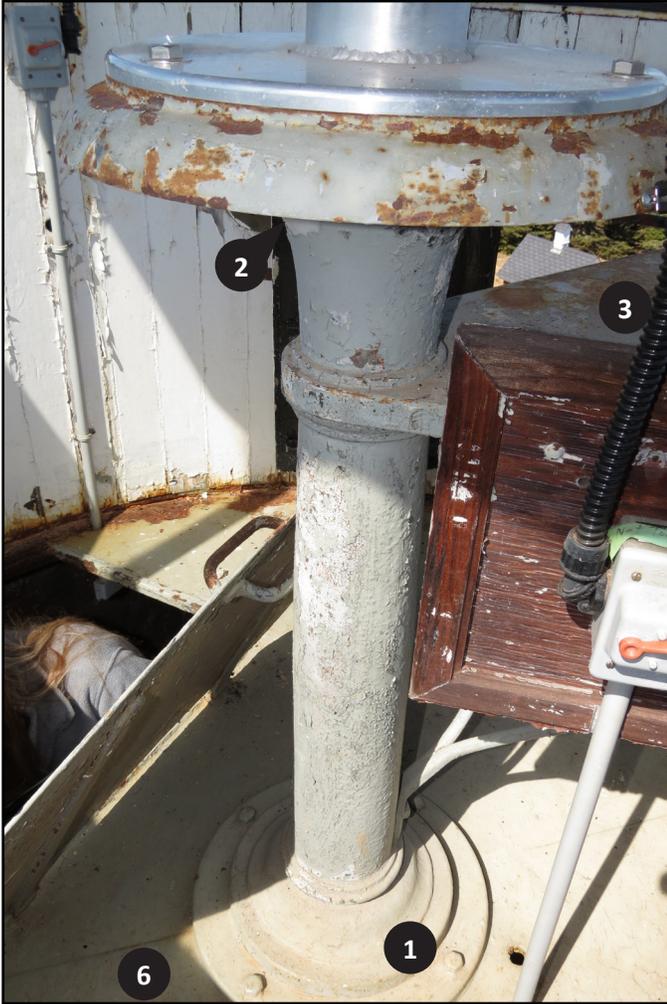
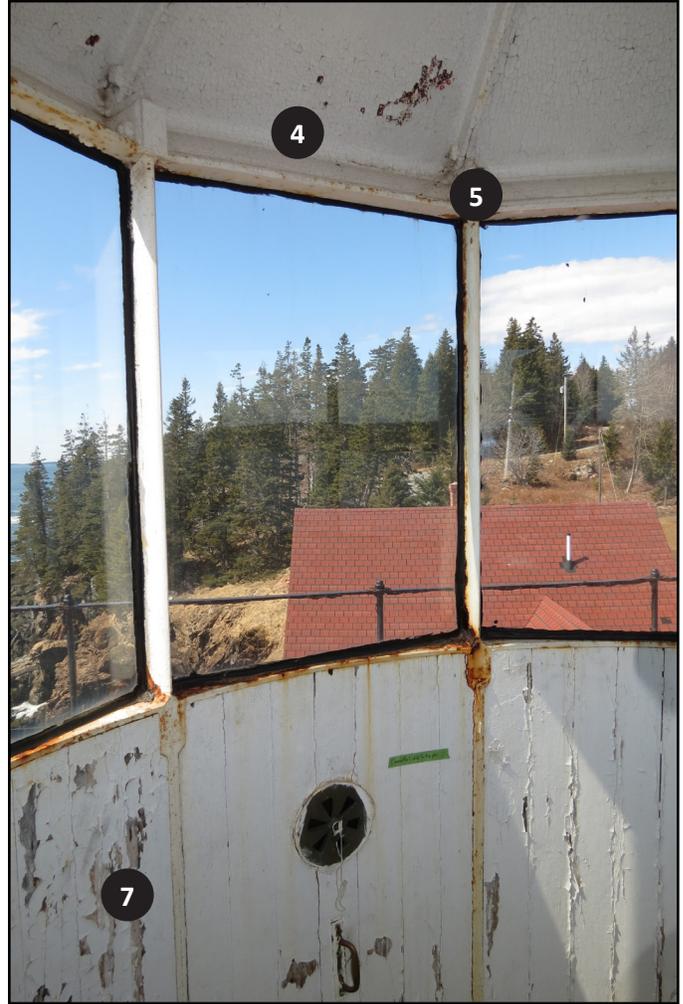
Lantern: Samples 1-7 were taken in the lantern from the original Fresnel lens pedestal, the metal floor, wood wainscoting, metal window frames and metal ceiling.

Fresnel Lens Pedestal: The combined stratigraphies of sample 1 taken from the base of the lens pedestal and sample 2 from the neck of the lens pedestal documents roughly 12-13 generations of green paint layers under roughly 7 generations of light to medium gray paint layers, ending with the gray paint applied during the summer of 2013. A red lead primer layer in a varnish separates the green paints from the gray paint layers. The pedestal base sample has more gray layers than the pedestal neck sample, and the pedestal neck sample has more green layers than the pedestal base sample. The earliest remaining paint on the pedestal neck sample (sample 2) appears as a partial layer of a granular dark gray paint in the cross section. This layer is readily visible in the uncast pieces of the sample as a thick, granular very dark gray / black layer. Sample 3 has the same gray generations (14-20) as sample 1 from the pedestal base.

The published 1891 and 1902 *Instructions by the Light-House Establishment* specified green paint for lens pedestals. The 1927 *Lighthouse Service Instructions* specified brown paint for lens pedestals. There is, however, no brown paint evidence in the pedestal paint samples. The 1952 *Coast Guard Paint Manual* specified No. 19 Light Gray for pedestals but also lists No. 12 Spruce Green as an alternate. As such, the documentary sources currently available for this analysis do not give us enough information to date the existing paint layers on the lens pedestal from these sources. An entry in a keeper's log or access to painting specifications between 1927 and 1952 could help provide more documentary evidence.

The thick red lead primer in sample 2 for the upper gray paint layers seeps down into the fragmented and broken top green layers which have the appearance of being disturbed by scraping or sanding. This disruption may indicate that paint layers are missing from the middle of the paint history due to a paint removal campaign prior to repainting. In sample 1, there is a partial layer of aluminum paint under the same orange colored red lead primer layer. Aluminum paint was widely used as a primer in the middle of the 20th century. The earliest reference for its use as a priming coat I have seen, however, is in the 1935 *Instructions for Painting United States Coast Guard Vessels, Boats, and Stations* intended for "all types of floating equipment." Section 4 – Use of Aluminum Paint explains it may "be used as a priming coat in lieu of red lead" and that aluminum paint "composed of aluminum powder in water-resisting spar varnish" should not be mistaken for the "ready-mixed bronzing paints" that had been used up until that time. As such it is likely the primer layer dates from the late 1930s or later (keeping in mind the Lighthouse Service was transferred over to the U.S. Coast Guard in 1939). While it cannot be unequivocally proven the green layers under this primer layer date from the 1930s (because the disturbed appearance of the top green layers seem to indicate paint layers were removed prior to the application of the primer coat) it may be a reasonable to say the pedestal could have been painted green at some point in the early 1930s because the dark autofluorescence of the middle and upper green layers in UV light indicate these are modern paints, which would have been available in the 1930s.

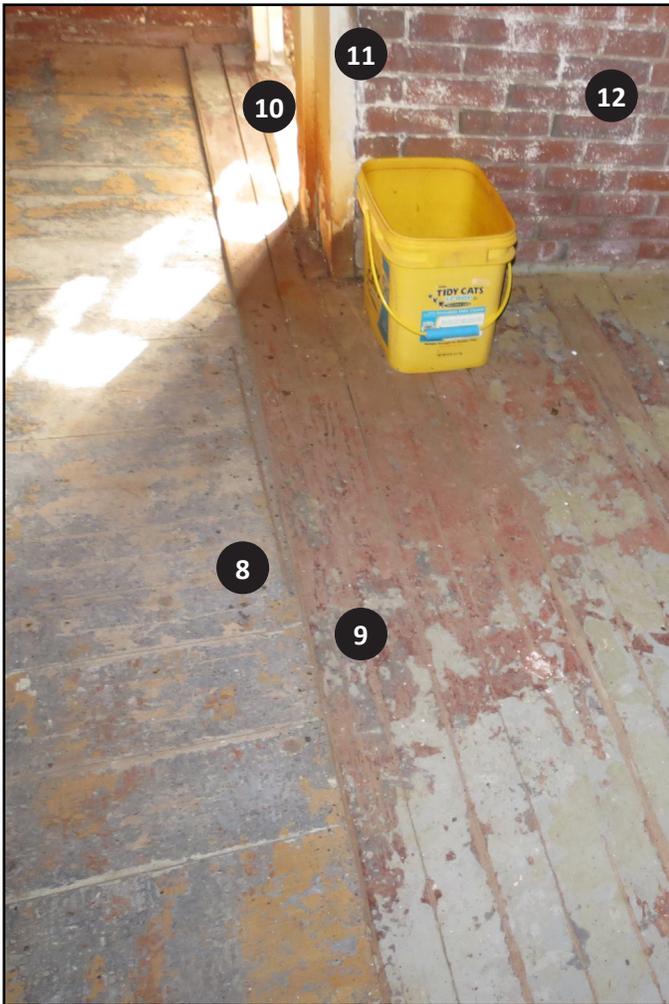
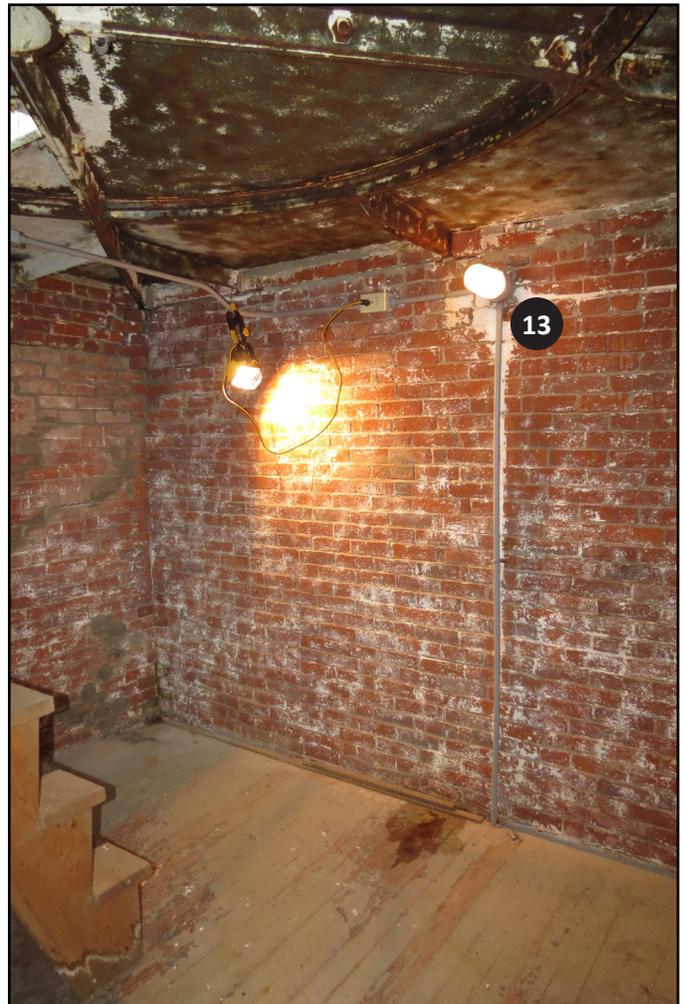
Watch Room: Samples 8-13 were taken in the watch room from the wood entrance partition wall, upper and lower floor boards and brick wall.

Door Frame and Partition: The door frame and the partition wall for the watch room (samples 11 and 12) contain only white paint layers. The earliest layer on the door frame appears to be a traditional linseed oil and white lead layer that is both in the pores of the wood and on top of the wood.

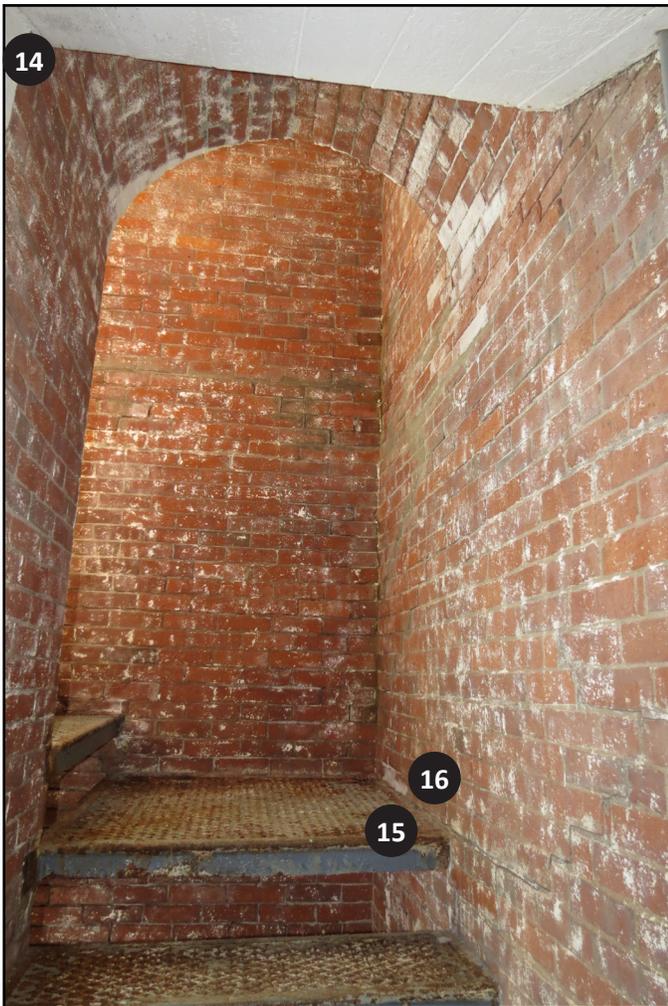
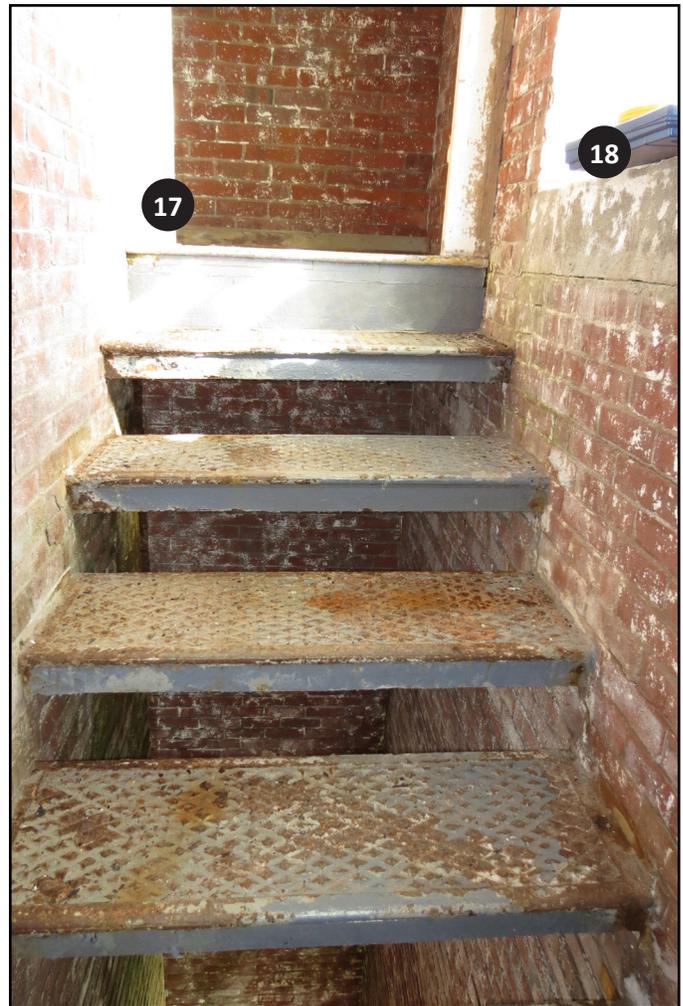
Tower: Samples 14-18 were taken in the tower from the underside of the watch room floor, the brick wall, iron stair treads and window openings.

Underside of Watch Room Floor: The watch room floor is wood joist construction set into the inner wythe of the exterior brick walls. On the west side of the tower a small brick barrel vault spans from the inner brick core of the tower to the exterior brick wall above the top run of stairs on the north side of the tower. On the east side of the brick vault is a rounded infill constructed with wood boards and a beaded board ceiling above the tower stairs adjacent to the watch room floor. This element appears to date from the original construction of the tower based on its materials and installation and because it is fastened to the wall with square headed nails. The paint layering on the wood elements above the stairway under the watch room floor (sample 14) is comprised of all white and off-white layers and includes what appears to be a traditional linseed oil and lead white layer as the earliest generation remaining visible in the fibers of the wood. Interestingly, the early oil paint also has a limewash above it in the layers, which is the finish historically used on the brick walls of the tower.
